**60% Design Level  
Independent Engineer Peer Review (IEPR)  
for the Dorena Hydroelectric Project**

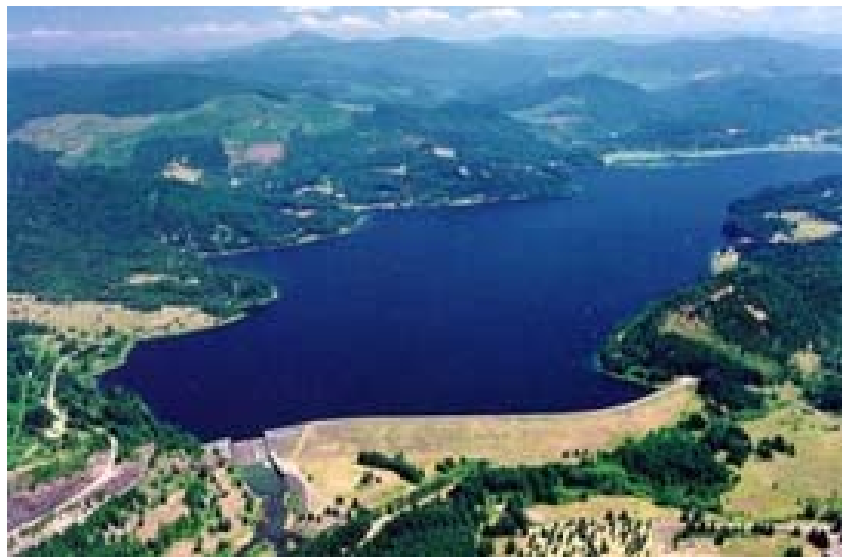
**Figure 2.1 - 2 - Photo of Dorena Lake Dam**

The Dorena Lake Dam is located on the Row River near Cottage Grove, Oregon. The dam is an earth-filled, gravel embankment structure with a crest length of 2,600 feet and a structural height of 145 feet. Appurtenant features of the dam include a concrete spillway with a 200-foot crest length at El 835 feet that discharges into a stilling basin constructed with concrete retaining walls and located within the concrete tailrace channel. The dam effectively raises the water level 114.5 feet above the stream bed of the Row River, creating a 1,749-acre reservoir that provides 70,500 acre-feet of

storage. The Dorena Lake project was completed in 1949 and is maintained and operated by the USACE. The current condition of the project appears to be good with no indication of circumstances that could limit the useful life of the project.
